Asbestos Sampling Report & Lead Based Paint Assessment

- Client is considering complete demolition of the home to rebuild in the same location.

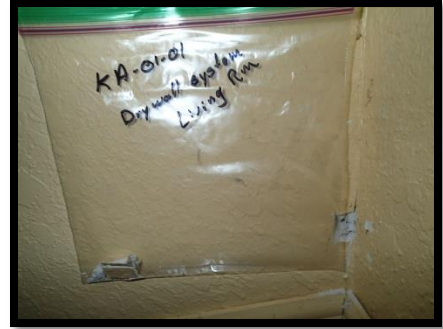
Homogeneous Sampling Area Number: [KA-01-01](#)

- Description of Material: Drywall system
- Color: Cream Pattern: None
- Condition: Good
- Category: MISC
- Locations: Living Room
- Quantity/Area: 4000 SF
- Sample Location Wall

Result: None Detected!

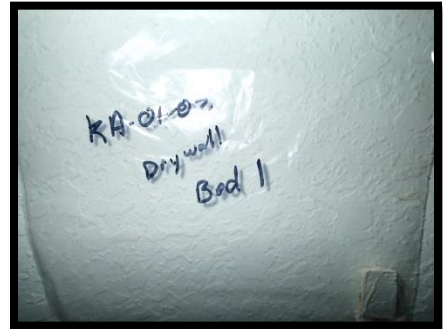
Homogeneous Sampling Area Number: [KA-01-02](#)

- Description of Material: Drywall system
- Color: White Pattern: None
- Condition: Good
- Category: MISC
- Locations: Bedroom
- Quantity/Area: 4000 SF
- Sample Location Wall

Result: None Detected!

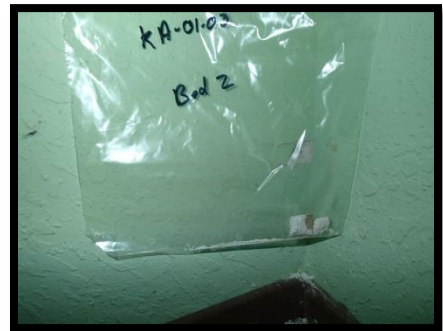
Homogeneous Sampling Area Number: [KA-01-03](#)

- Description of Material: Drywall system
- Color: Green Pattern: None
- Condition: Good
- Category: MISC
- Locations: Bedroom 2
- Quantity/Area: 4000 SF
- Sample Location Wall

Result: None Detected!

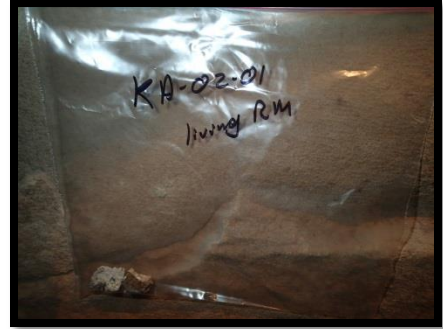
Homogeneous Sampling Area Number: [KA-02-01](#)

- Description of Material: Mortar
- Color: Grey Pattern: None
- Condition: Good
- Category: MISC
- Locations: Living Room
- Quantity/Area: 80 SF
- Sample Location Fireplace

Result: None Detected!

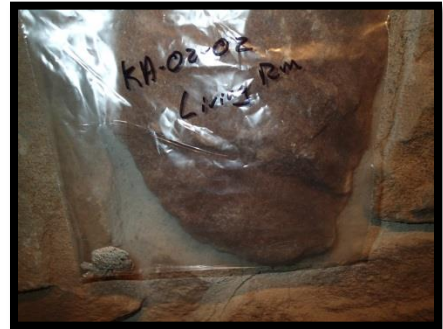
Homogeneous Sampling Area Number: [KA-02-02](#)

- Description of Material: Mortar
- Color: Grey Pattern: None
- Condition: Good
- Category: MISC
- Locations: Living Room
- Quantity/Area: 80 SF
- Sample Location Fireplace

Result: None Detected!

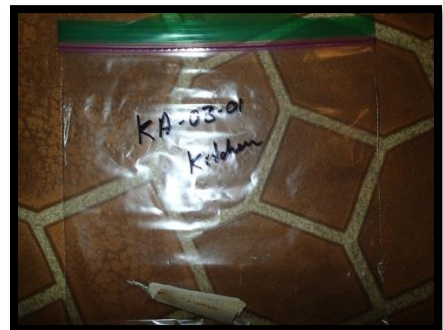
Homogeneous Sampling Area Number: [KA-03-01](#)

- Description of Material: Sheet Flooring
- Color: Earth Tones Pattern: Grid
- Condition: Good
- Category: MISC
- Locations: Kitchen
- Quantity/Area: 90 SF
- Sample Location Floor

Result: Asbestos Detected! Material: Gray fibrous Type: Chrysotile Amount: 45%
Result: Asbestos Detected! Material: Tan mastic Type: Chrysotile Amount: 2%

- If asbestos is detected in any of the materials tested, contact a certified asbestos abatement firm to provide a protocol and pricing for proper abatement. The EPA's website has a full list of qualified asbestos abatement companies in the State of Washington for all areas.

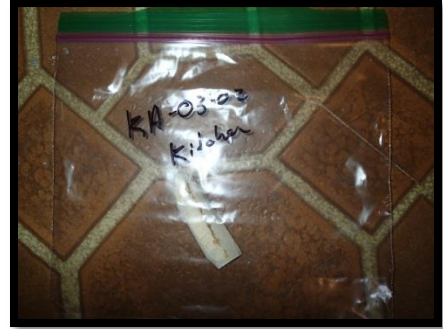
Homogeneous Sampling Area Number: [KA-03-02](#)

- Description of Material: Sheet Flooring
- Color: Earth Tones Pattern: Grid
- Condition: Good
- Category: MISC
- Locations: Kitchen
- Quantity/Area: 90 SF
- Sample Location Floor

Result: Asbestos Detected! Material: Gray fibrous Type: Chrysotile Amount: 45%
Result: Asbestos Detected! Material: Tan mastic Type: Chrysotile Amount: 2%

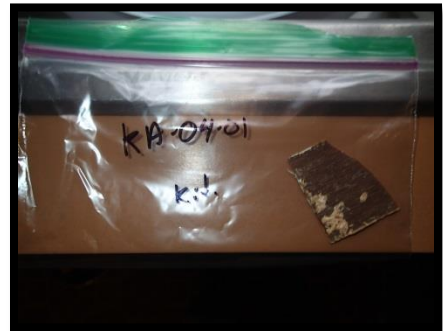
Homogeneous Sampling Area Number: [KA-04-01](#)

- Description of Material: Formica
- Color: Beige Pattern: None
- Condition: Good
- Category: MISC
- Locations: Kitchen
- Quantity/Area: 40 SF
- Sample Location Counter top

Result: None Detected!

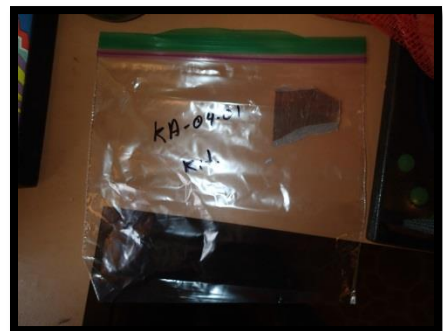
Homogeneous Sampling Area Number: [KA-04-02](#)

- Description of Material: Formica
- Color: Beige Pattern: None
- Condition: Good
- Category: MISC
- Locations: Kitchen
- Quantity/Area: 40 SF
- Sample Location Counter top

Result: None Detected!

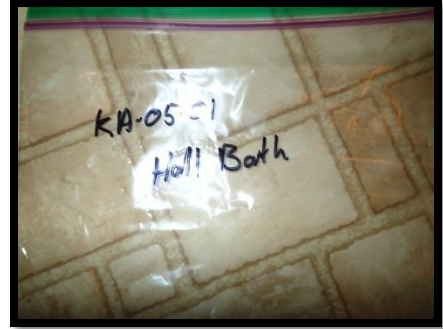
Homogeneous Sampling Area Number: [KA-05-01](#)

- Description of Material: Sheet Flooring
- Color: Earth Tones Pattern: Grid
- Condition: Good
- Category: MISC
- Locations: Hall Bath
- Quantity/Area: 40 SF
- Sample Location Floor

Result: Asbestos Detected! Material: Gray fibrous Type: Chrysotile Amount: 45%
Result: Asbestos Detected! Material: Yellow mastic Type: Chrysotile Amount: 2%

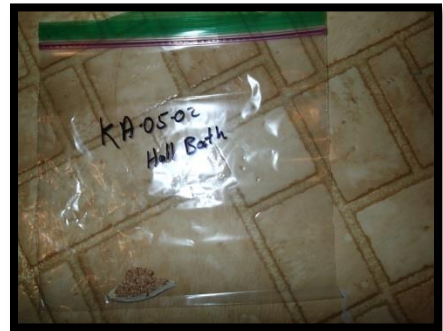
Homogeneous Sampling Area Number: [KA-05-02](#)

- Description of Material: Sheet Flooring
- Color: Earth Tones Pattern: Grid
- Condition: Good
- Category: MISC
- Locations: Hall Bath
- Quantity/Area: 40 SF
- Sample Location Floor

Result: Asbestos Detected! Material: Gray fibrous Type: Chrysotile Amount: 45%
Result: Asbestos Detected! Material: Yellow mastic Type: Chrysotile Amount: 2%

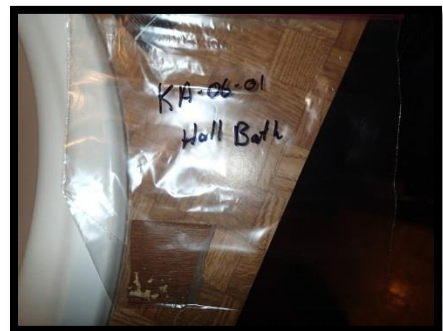
Homogeneous Sampling Area Number: [KA-06-01](#)

- Description of Material: Formica
- Color: Beige Pattern: None
- Condition: Good
- Category: MISC
- Locations: Hall Bath
- Quantity/Area: 6 SF
- Sample Location Counter top

Result: None Detected!

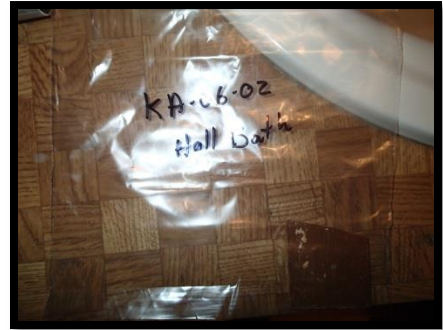
Homogeneous Sampling Area Number: [KA-06-02](#)

- Description of Material: Formica
- Color: Beige Pattern: None
- Condition: Good
- Category: MISC
- Locations: Hall Bath
- Quantity/Area: 6 SF
- Sample Location Counter top

Result: None Detected!

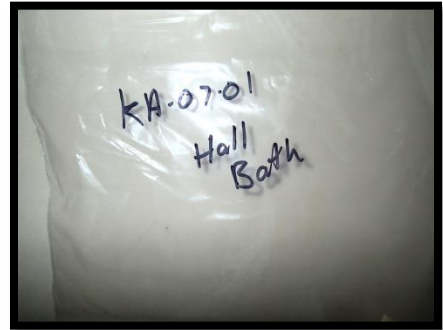
Homogeneous Sampling Area Number: [KA-07-01](#)

- Description of Material: Cultured Marble
- Color: Light Grey Pattern: Swirl
- Condition: Good
- Category: MISC
- Locations: Hall Bath
- Quantity/Area: 140 SF
- Sample Location Wall

Result: None Detected!

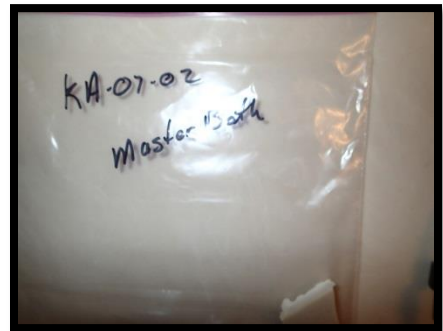
Homogeneous Sampling Area Number: [KA-07-02](#)

- Description of Material: Cultured Marble
- Color: Light Grey Pattern: Swirl
- Condition: Good
- Category: MISC
- Locations: Master Bath
- Quantity/Area: 140 SF
- Sample Location Wall

Result: None Detected!

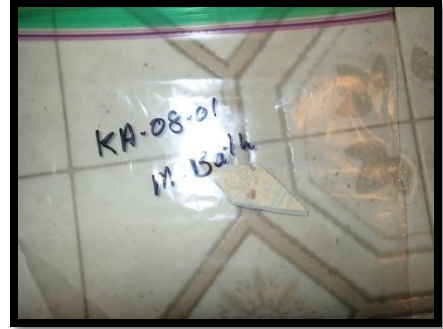
Homogeneous Sampling Area Number: [KA-08-01](#)

- Description of Material: Sheet Flooring
- Color: Light Earth Tones Pattern: Grid
- Condition: Good
- Category: MISC
- Locations: Master Bath
- Quantity/Area: 50 SF
- Sample Location Floor

Result: Asbestos Detected! Material: Gray fibrous Type: Chrysotile Amount: 45%
Result: Asbestos Detected! Material: Yellow mastic Type: Chrysotile Amount: 2%

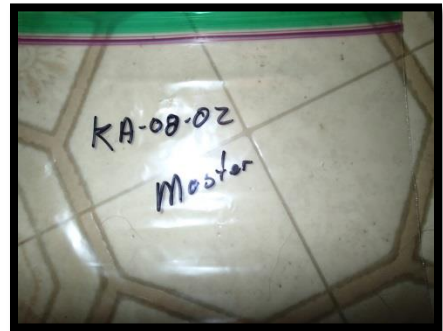
Homogeneous Sampling Area Number: [KA-08-02](#)

- Description of Material: Sheet Flooring
- Color: Light Earth Tones Pattern: Grid
- Condition: Good
- Category: MISC
- Locations: Master Bath
- Quantity/Area: 50 SF
- Sample Location Floor

Result: Asbestos Detected! Material: Gray fibrous Type: Chrysotile Amount: 45%
Result: Asbestos Detected! Material: Yellow mastic Type: Chrysotile Amount: 2%

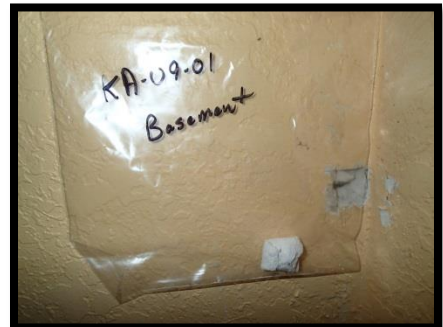
Homogeneous Sampling Area Number: [KA-09-01](#)

- Description of Material: Drywall system
- Color: Cream Pattern: None
- Condition: Good
- Category: MISC
- Locations: Basement
- Quantity/Area: 2000 SF
- Sample Location Wall

Result: None Detected!

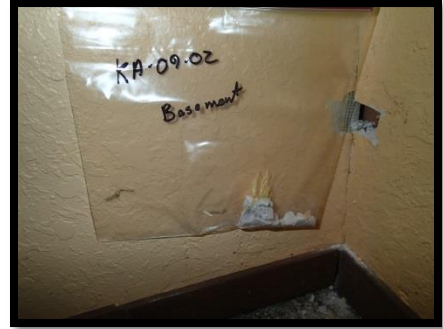
Homogeneous Sampling Area Number: [KA-09-02](#)

- Description of Material: Drywall system
- Color: Cream Pattern: None
- Condition: Good
- Category: MISC
- Locations: Basement
- Quantity/Area: 2000 SF
- Sample Location Wall

Result: None Detected!

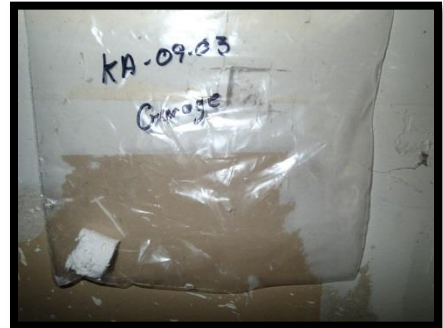
Homogeneous Sampling Area Number: [KA-09-03](#)

- Description of Material: Drywall system
- Color: White Pattern: None
- Condition: Good
- Category: MISC
- Locations: Garage
- Quantity/Area: 2000 SF
- Sample Location Wall

Result: None Detected!

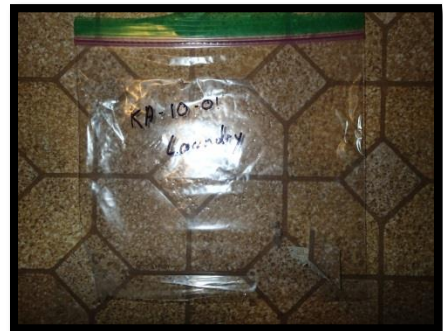
Homogeneous Sampling Area Number: [KA-10-01](#)

- Description of Material: Sheet Flooring
- Color: Earth Tones Pattern: Grid
- Condition: Good
- Category: MISC
- Locations: Laundry Room
- Quantity/Area: 80 SF
- Sample Location Floor

Result: None Detected!

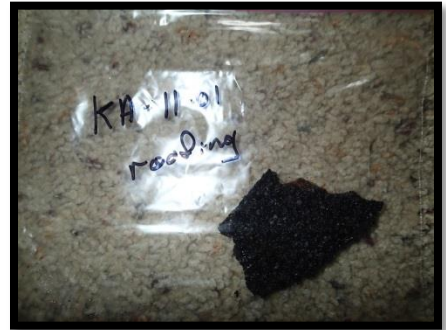
Homogeneous Sampling Area Number: [KA-11-01](#)

- Description of Material: Asphalt Shingles
- Color: Black Pattern: None
- Condition: Good
- Category: MISC
- Locations: Exterior
- Quantity/Area: 2000 SF
- Sample Location Roof

Result: None Detected!

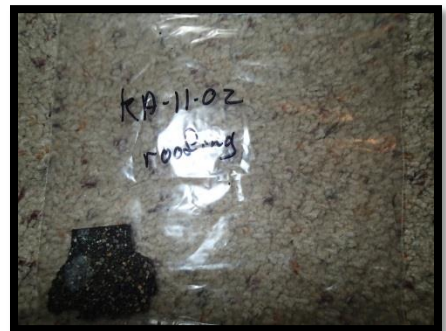
Homogeneous Sampling Area Number: [KA-11-02](#)

- Description of Material: Asphalt Shingles
- Color: Black Pattern: None
- Condition: Good
- Category: MISC
- Locations: Exterior
- Quantity/Area: 2000 SF
- Sample Location Roof

Result: None Detected!
